BLM-Alaska Open File Report 64  
BLM/AK/ST-97/022+8111+040  
April 1997

# HISTORIC BUILDING SURVEY REPORT FLAT, ALASKA

by Rolfe G. Buzzell and Darrel L. Lewis

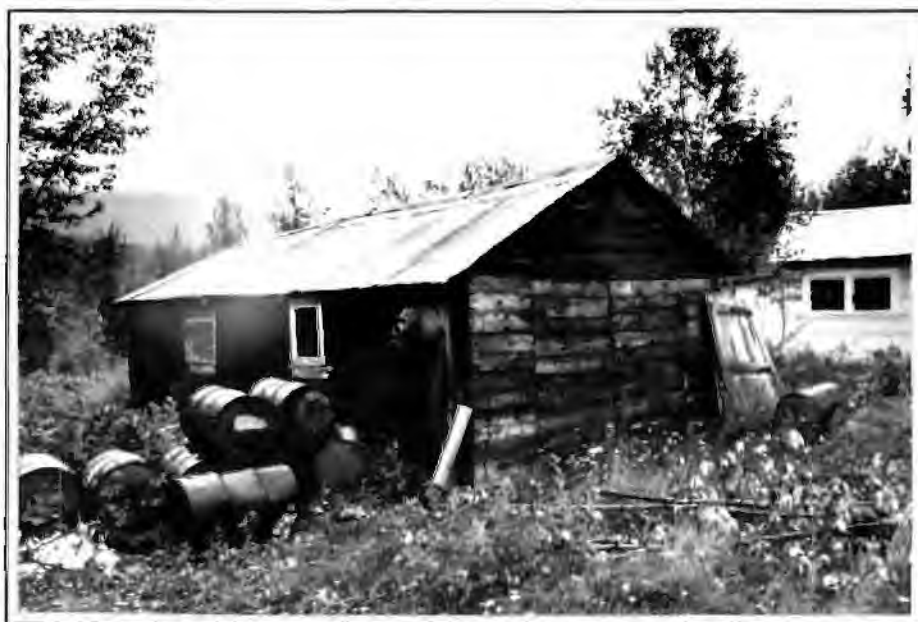
The **Jensen/Parker/Stevens/Stuver Garage (IDT-163)** is a rectangular, one-story, wood frame building (Figure 120). The foundation is on grade. The gable roof is covered with corrugated metal. The garage measures 15'x30'7" and is sided with shiplap and horizontal wood siding. The main entry is on the south elevation, which has a pair of large side opening plank doors. Two single-light, fixed sash windows are located on the east and west elevations. A personnel door and a window opening on the north elevation are covered with corrugated metal. A stove pipe insulator is sticking out the south end of the west elevation.

A small meat drying facility is located 11' northeast of the garage. It is a square, one-story, wood frame structure. The foundation is on grade and the gable roof is covered with roofing felt over wood decking. Each side is 6' long. The lower half of the walls are covered with wood siding and the upper half is screened. A plank door is located on the north elevation.

Figure 120. The Jensen/Parker/Stevens/Stuver Garage, 1993. The view is looking northeast.

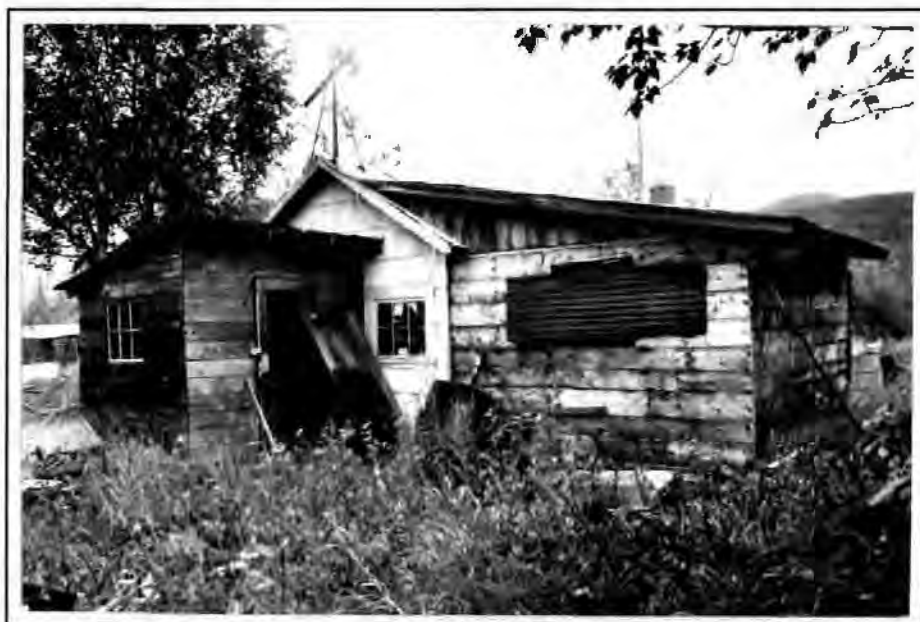
The Dukich/Parker/Jimmy Flemings House (IDT-164) is a rectangular, one-story, wood frame building with three additions (Figure 121). The foundation is not visible. Corrugated metal covers the gable roof of the house and roofs of the three shed additions. The building measures 12'2"x14'1". The exterior walls are covered with wood shingles. The main entry is on the south elevation, which contains a six-light, fixed sash window and a shed roof addition. The addition measures 2'10"x7'8". The exterior is covered with shiplap. The east elevation contains a three-panel door with one light. The south and west elevations each have a six-light, fixed sash window. The west elevation of the house contains a pair of two-light, fixed sash windows. A shed roof addition on the east side of the house measures 11'2"x14'1". The exterior walls of the east addition are covered with shiplap. A boarded up window is located on the north and south elevations of this addition. Another shed roof addition measuring 9'11"x12'2" is located on the north side of the house. Corrugated metal covers the exterior walls. A four-panel door is located on the west elevation of the north addition.

Figure 121. The Dukich/Parker/Jimmy Flemings House, 1993. The view is looking northwest.

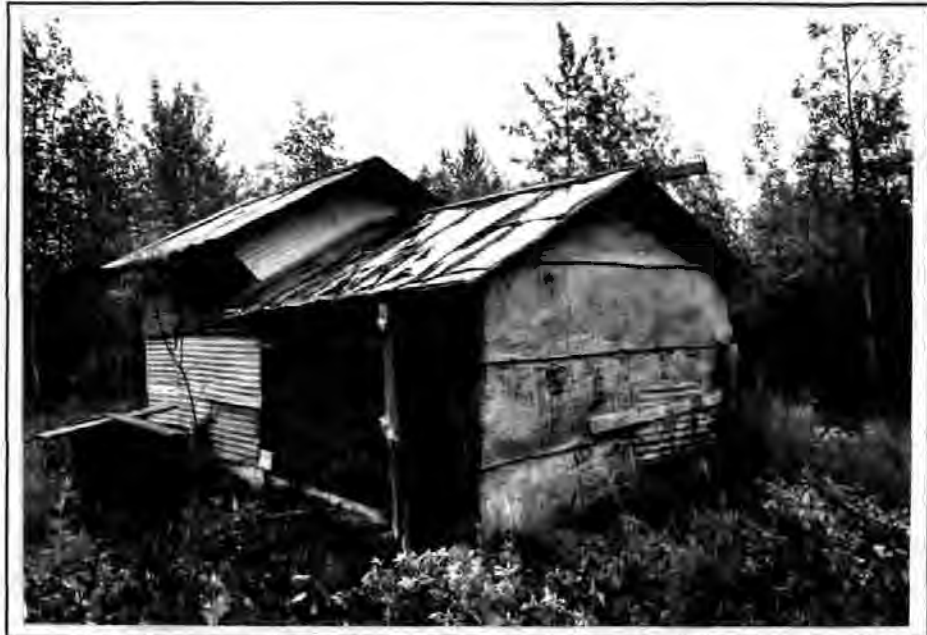
The **Parker/Flemings Meat Shed (IDT-165)** is a rectangular, one-story, wood frame building and addition (Figure 122). The foundation is on grade and the building has a dirt floor. The building and addition have gable roofs positioned end to end. Corrugated metal covers the roof and exterior walls of the building except for the screening under the eaves and gables. The main portion of the building measures 9'10"x10'6"

**Figure 122. The Parker/Flemings Meat Shed, 1993. The view is looking southeast.**

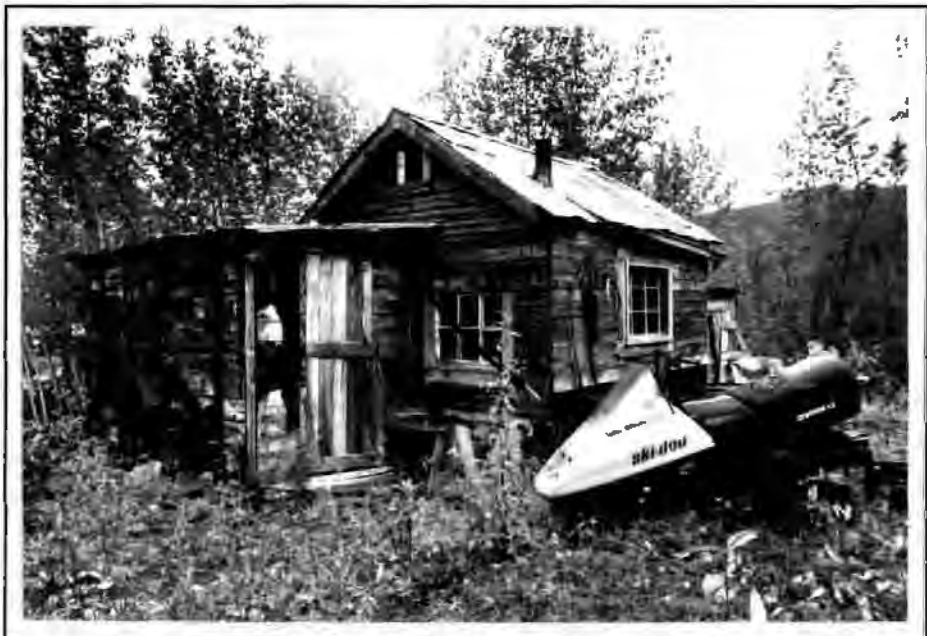
The **Nevella/Johnson/Flemings/Crammer House (IDT-166)** is a rectangular, 1.5 story, wood frame building (Figure 123). The

**Figure 123. The Nevella/Johnson/Flemings/Crammer House, 1993. The view is looking northwest.**

foundation is not visible. Corrugated metal covers the gable roof. The house measures 10'6"x12'6". The exterior walls are covered with roofing felt over shiplap on the north and west elevations, and shiplap on the south and east elevations. The main entry is on the south elevation, which includes a six-light, fixed sash window, a single-light, fixed sash window in the south gable, and a shed roof arctic entry measuring 6'6" x 8'11". The roof of the addition is covered with corrugated metal and the exterior is covered with roofing felt over wood siding. The east elevation of the addition has a plank door and the west elevation has a single-light, fixed sash window. A six-light, fixed sash window is centered on the west elevation of the house and a nine-light, fixed sash window is centered on the east elevation.

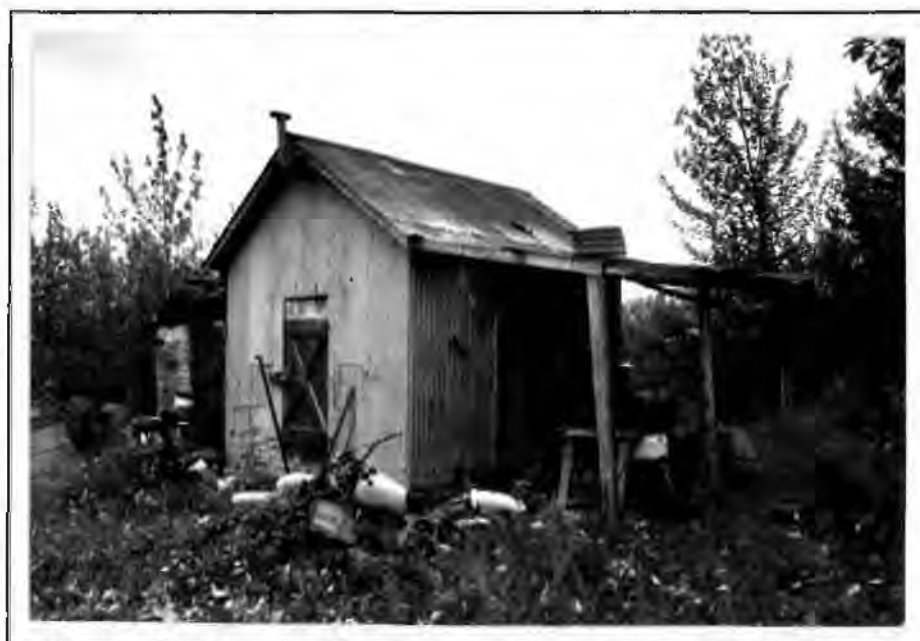
The Turner/Floyd/Stevens/Olsen Shop (IDT-167) is a rectangular, one-story, wood frame building (Figure 124). The foundation is wood blocks on grade. Corrugated metal covers the gable roof and exterior walls. The

building measures 11'11"x12'. A vertical plank door is centered on the east elevation. A shed addition on the south side of the building is open on the west elevation. Corrugated metal covers the roof. Shiplap siding covers the south and east walls. A shed roof addition on the north side has no walls. Corrugated metal covers the roof. A row of metal fuel drums is located on the west side of the building.

Figure 124. The Turner/Floyd/Stevens/Olsen Shop, 1993. The view is looking southwest.

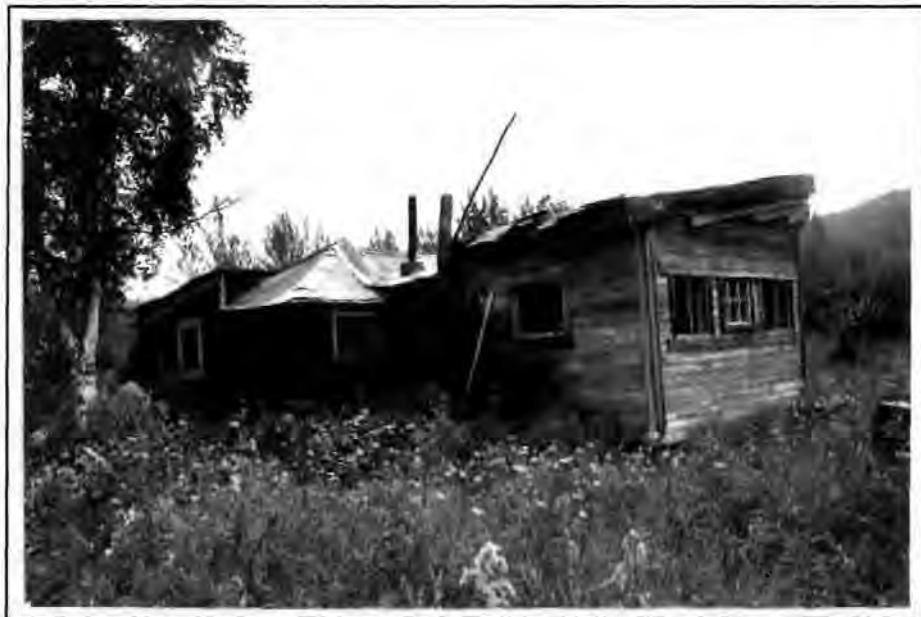
The **Marcell/Dahl/Stevens/Friend/Olsen House (IDT-168)** is an irregular shaped, one-story, wood frame building with four additions (Figure 125). The foundation consists of wooden blocks on grade. The roofs of the house and the four additions are covered with corrugated metal. The oldest section of the house measures 12'x12'8" and had a gable roof. The original house appears to have been "L" shaped with a shed roof addition in the northeast corner. Roofing felt covers the exterior walls. The main entry is on the south elevation, which includes a one-light, fixed sash window and a hipped roof addition measuring 6'5"x8'. The exterior of the addition is covered with roofing felt. The south addition has a two-panel door with one light facing south and a six-light, fixed sash window facing east. A shed roof addition on the west side of the house measures 11'5"x18'4". Roofing felt covers the exterior walls. The south elevation has a single-light, fixed sash window and the west elevation has two six-light, fixed sash windows. A shed addition on the north side of the house measures 7'1"x23'9" and the exterior is covered with roofing felt. The north addition has a single-light, fixed sash

**Figure 125. The Marcell/Dahl/Stevens/Friend/Olsen House, 1993. The view is looking northwest.**

window on the west side, and a door way and a six-light, fixed sash window on the north elevation. On the east side of the building is an addition with a shed roof. The east addition measures 10'11"x13' and the exterior is sided with scalloped shiplap with corner boards. The south elevation has a single-light, fixed sash window and the north elevation has a four-panel door. The east elevation has a six-light, fixed sash window flanked on each side by a two-light, fixed sash window.

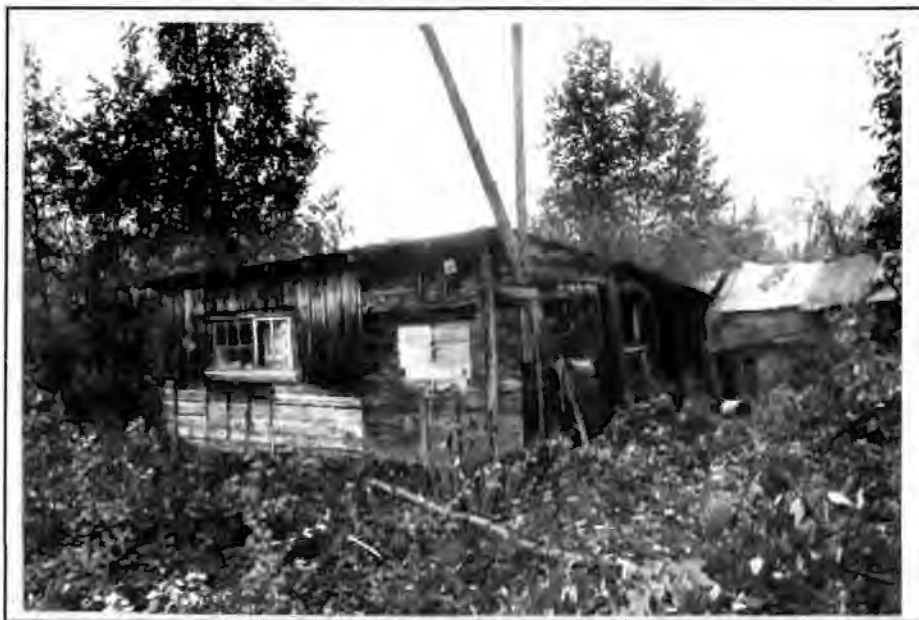
**The Stenberg/  
Gustafson/Olsen  
Shed (IDT-169)** is a rectangular, one-story, log and wood frame building with two additions (Figure 126). The foundation is logs on grade and the shed roof is covered with corrugated metal. The oldest (northwest) portion of the building measures 11'10"x13'7". The lower walls are made of logs and the upper walls are framed and covered with vertical wood siding. A six-light, fixed sash window and

**Figure 126. The Stenberg/Gustafson/Olsen Shed, 1993. The view is looking northeast.**

a two-light, fixed sash window are centered on the west side. A shed addition on the south side measures 7'x11'10". The roof is covered with corrugated metal and the exterior is covered with wood siding. The south elevation contains a pair of utility doors and a window frame. A boarded up window is located on the west elevation. A shed addition on the east side of the building measures 7'10"x20'7". The exterior walls of the addition are covered with shiplap. A double-wide entry with the remains of two plank doors are on the north elevation and there is a door opening on the south elevation.

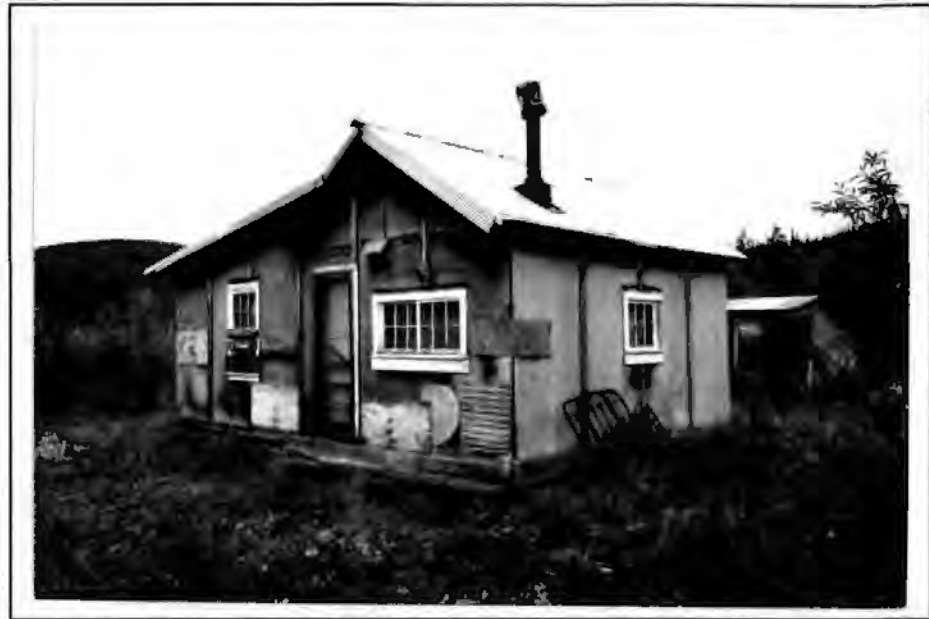
(Figure 128). The foundation is logs on grade. Corrugated metal covers the gable roof and the shed roof addition. Celotex covers all of the exterior walls. The house measures 12'x16'. The main entry is on the south elevation, which includes a five-panel door and a 6/6 horizontal double-hung window. A six-light, fixed sash window is centered on the east elevation. A shed addition on the west side of the house measures 12'x16'. A 6/6 double-hung window is centered on the south elevation. A 2/2 horizontal double-hung window is located on the west elevation and a five-panel door is located on the north elevation.

**Figure 128. The Williams/Bacstrom/Blackwell/Pierson House, 1993. The view is looking northwest.**

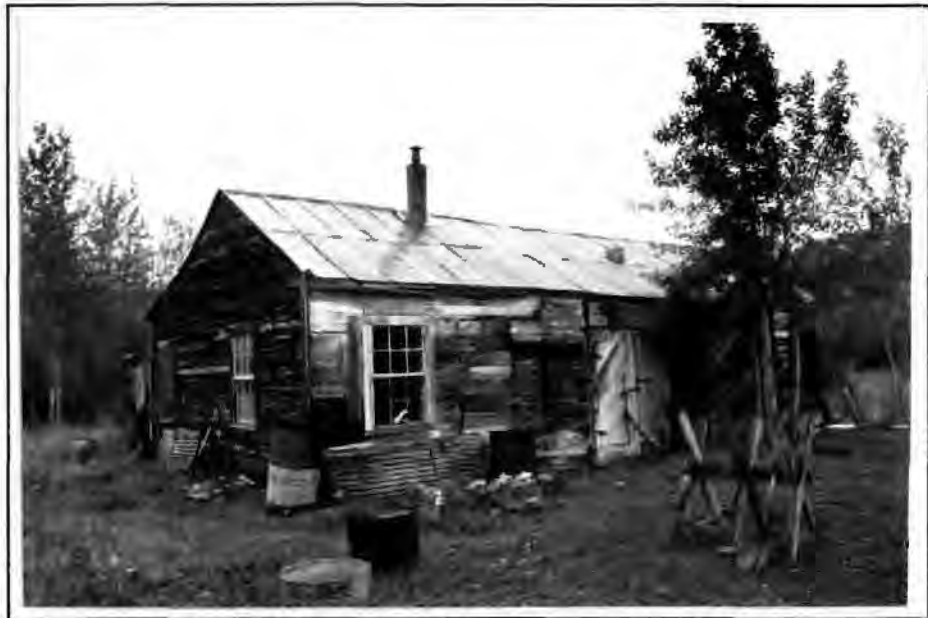
The Alaska Road Commission (ARC) Repair Shop (IDT-171) is a "L" shaped, one-story, wood frame building (Figure 129). The foundation is not visible. Corrugated metal covers the gable roof. The building measures 19'10"x39'10". The exterior walls are covered with shiplap except the north wall which is covered with corrugated metal. The main entry is on the south elevation, which features two pairs of large, side opening plank doors, a 6/6 single-hung window, and a boarded over door. A 6/6 single-hung window is located on the south elevation and a six-light, fixed sash window is located on the north elevation. A small 6'8"x8'10" shed roof addition is located on the north end of the west elevation. The roof is covered with corrugated metal and the exterior is sided with shiplap. This addition has a six-light, fixed sash window facing north. A plank door and a six-light, fixed sash window faces west. A 5'1"x6'4" shed roof addition is located on the south end of the west elevation of the building. The roof is covered with corrugated metal and the exterior is sided with shiplap. A 6/6 single-hung window faces south. A large gable roofed addition on the west side of the building gives the complex an "L" shape. The west addition measures 18'x31'7". Corrugated metal covers the roof and exterior walls. The addition has a two-light, fixed sash window facing south and a window frame with no glass facing west. An arctic entry measuring 5'2"x6'4" is located on the east end of the south side of this addition. The arctic entry has a shed roof

covered with corrugated metal and the exterior is covered with roofing felt. A five-panel door faces west and a boarded up window faces south. A shed roofed addition measuring 8'x20'2" is located on the north side of the west addition. The roof and exterior walls are covered with corrugated metal. The north elevation of the addition has two window openings without glass and a plank door.

**Figure 129. The ARC Repair Shop, 1993.**  
The view is looking northwest.

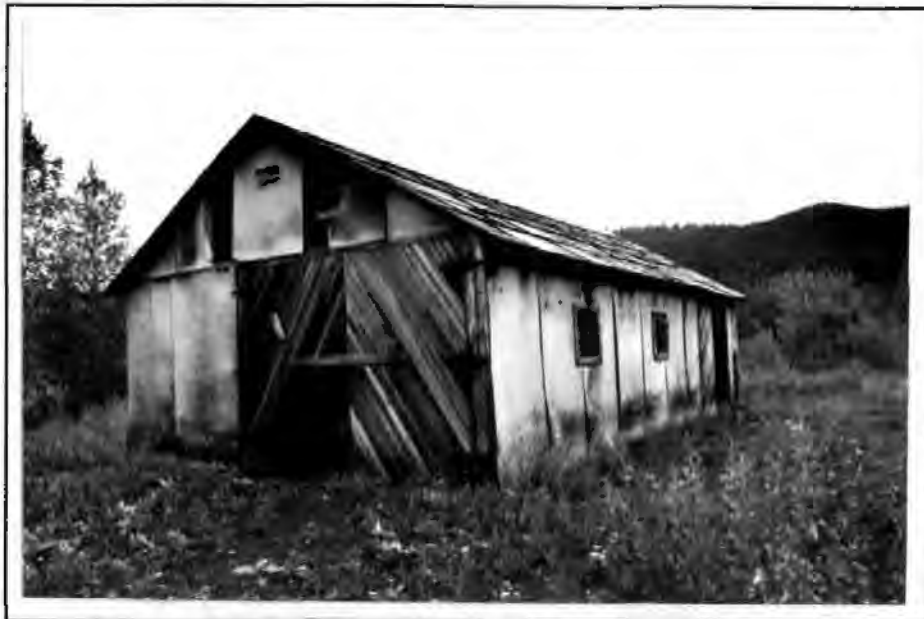
The **Alaska Road Commission Garage (IDT-172)** is a rectangular, one-story, wood frame building (Figure 130). The foundation is on grade and roofing felt covers the gable roof. The building measures 20'x40' and the exterior walls are covered with celotex. The east elevation contains a pair of large, side opening plank doors and two single-light, fixed sash windows. Another pair of large, side opening plank doors is located on the south elevation. A personnel door made of vertical tongue and groove boards and a window frame with no glass are located on the north elevation. Two window openings without glass are located on the west elevation.

**Figure 130. The ARC Garage, 1993.**  
The view is looking northwest.

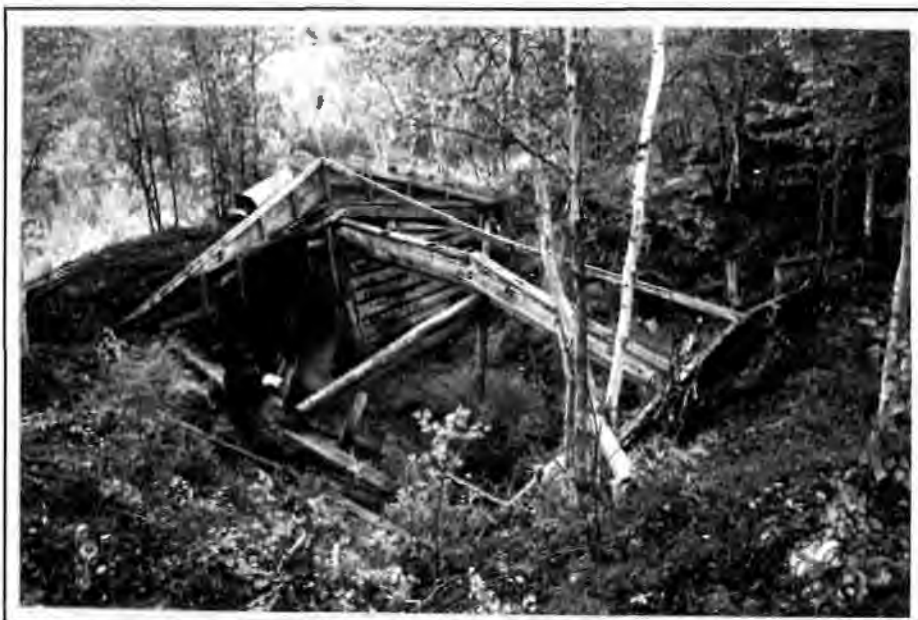
consists of the ruins of a rectangular, one-story, semi-subterranean, log building (Figure 131). The structure was built into the hillside just north of the Flat-Iditarod Road at the northwest edge of Flat. With the exception of the roof and south facing entry, the building is underground. The foundation is below grade. The gable roof has collapsed and the roofing material, except for the log ridge pole, a ridge board and two rafters, have been salvaged. The building measures 24'2"x25'7". The south wall is standing, but the north, east, and west walls are partially collapsed. The only entry to the building is on the south side facing the road. The log lined entry, which was excavated out of the hillside facing the road, measures 4'x6' and is the only part of the structure visible from the road.

**Figure 131. The Gularte/Donnelley and Sheppard Warm Storage Building, 1993.** The view is looking southwest.

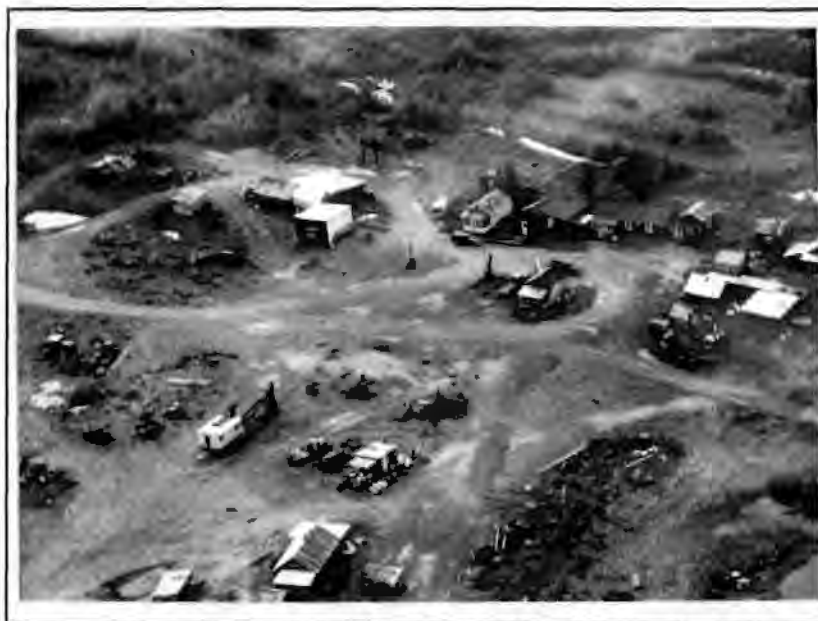
The Riley/Otter Creek Dredging Company Mining Camp (Riley/Otter Creek Camp) (IDT-201) is located about one mile east of the town of Flat. The camp consists of a complex of buildings, structures, and equipment associated with the Riley Dredge. The complex (Figure 132) is made up of twenty buildings, including bunkhouses, a mess hall, garages, workshops, sheds, and offices, and one structure, a steam shovel (Figure 133). All of the buildings are one-story, wood framed structures in good condition. The camp also includes early mining equipment collected by John Miscovich.

**Figure 132. Aerial view of the Riley/Otter Creek Mining Camp. The view is looking northwest. Photo courtesy of John Miscovich, ca 1990.**

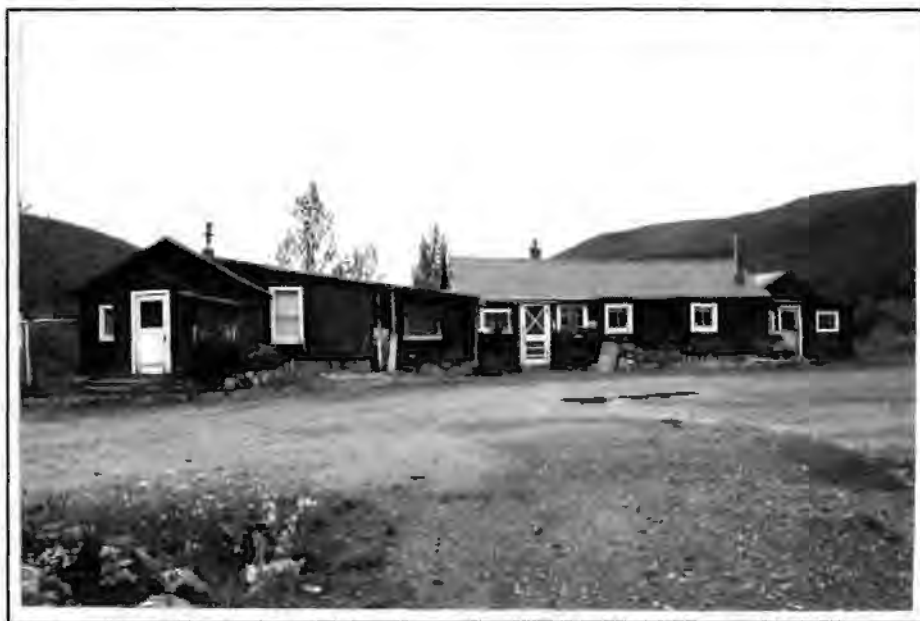
The **Mess Hall Building (IDT-202)** is a one-story, wood frame building with six additions (Figure 134). The foundation is wood blocks. The exterior of the Mess Hall and the five additions are covered with roofing felt. The gable roof is roofing felt covered with corrugated metal. The Mess Hall measures 24"x38'7". The main entry is on the south elevation, which has two two-light, fixed sash windows and a three-panel door with one light. The door is covered by an arctic entry with a shed roof. The entry measures 7'x15' and the roof is covered with corrugated metal. The south elevation of the entry has a three-panel door with one light, a six-light, fixed sash window, and a nine-light, fixed sash window. The north elevation of the Mess Hall has a two-light, fixed sash window, a 2/2 double-hung horizontal window, and a window that is covered with corrugated metal.

A one-story shed roof addition measuring 14'4"x24' is located west of the Mess Hall. The shed roof is covered with roofing felt and canvas. A single-light, fixed sash window faces

north and a single-light, fixed sash window faces south. Another one-story shed roof addition to the west measures 10'x26'. The roof is covered with corrugated metal. The south elevation has a one-light, fixed sash window. A one-story, rectangular gable roof addition at the west end of the building measures 18'x19'3". The south elevation has a two-light, fixed sash window and a five-panel door. An

**Figure 134. The Mess Hall Building at the Riley/Otter Creek Camp, 1993. The view is looking north.**

arctic entry with a gable roof measuring 5'1"x6'3" covers the door. The arctic entry has a one-panel door with one light. A shed roof addition on the east side of the arctic entry measures 4'11"x7'9". It has a one-light, fixed sash window facing south. The roofs of the arctic entry and the shed addition are covered with roofing felt.

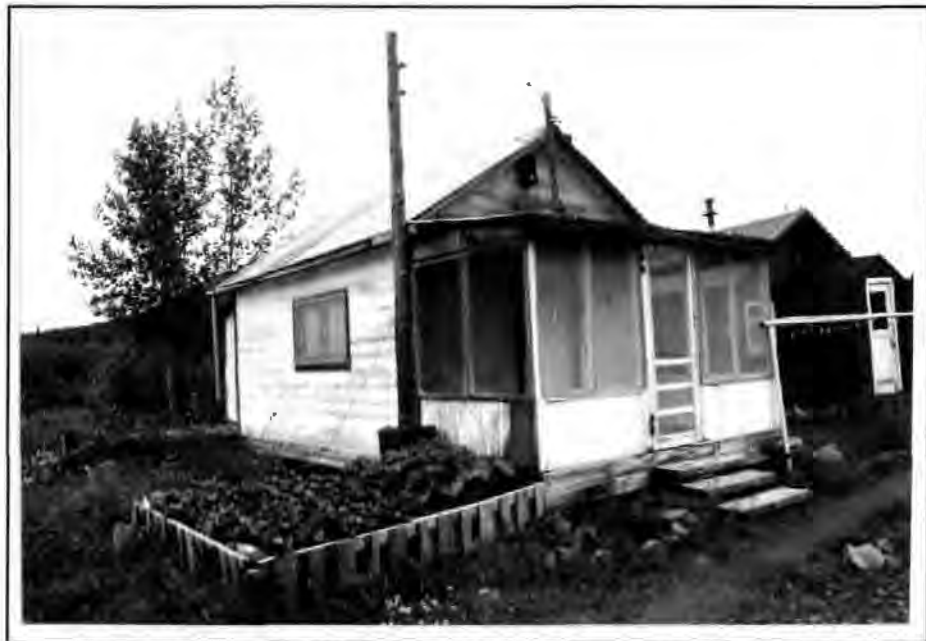
The **Pomgran/Aiken/Miscovich Guesthouse (IDT-203)** is a rectangular, one-story wood frame building (Figure 135). It measures 12'3"x18'4" and the foundation is wood blocks. The gable roof is covered with corrugated metal. The exterior is covered with shiplap and corner boards. The main entry is on the south elevation, which has a single-panel door with one light covered by a 6'x12'3" screen porch. The porch has a shed roof covered with corrugated metal. The east elevation has a one-light, fixed sash window. The west elevation has a 1/1 single-hung horizontal window. The north elevation has a five-panel door covered by an addition measuring 5'2"x10'5". The addition has a shed roof covered by roofing felt. The north elevation of the addition has two six-light, fixed sash windows. A boarded up doorway faces west.

**Figure 135. The Pomgran/Aiken/Miscovich Guesthouse, 1993. The view is looking northeast.**

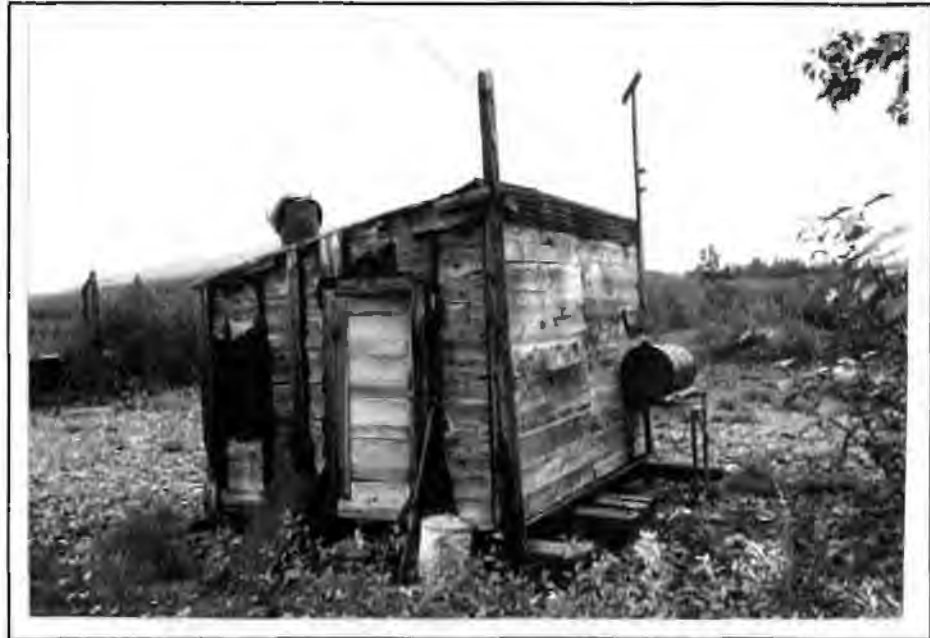
The **Generator Shed (IDT-204)** is a rectangular, one-story, wood frame building (Figure 136) located 25' northwest of the Pomgran/Aiken/Miscovich Guesthouse (IDT-203). The foundation is logs. The shed roof is covered with corrugated metal. The Generator Shed measures 10'10"x12'4". The exterior is covered with roofing felt over wood decking. A five-panel door is located on the south elevation. A six-light, fixed sash window is located on the north elevation. A window covered with corrugated metal is located on the west elevation. A cable attached to the foundation on the north side indicates that the shed is made to be towed. A generator is located inside the shed.

**Figure 136. The Generator Shed, 1993.**  
The view is looking northeast.

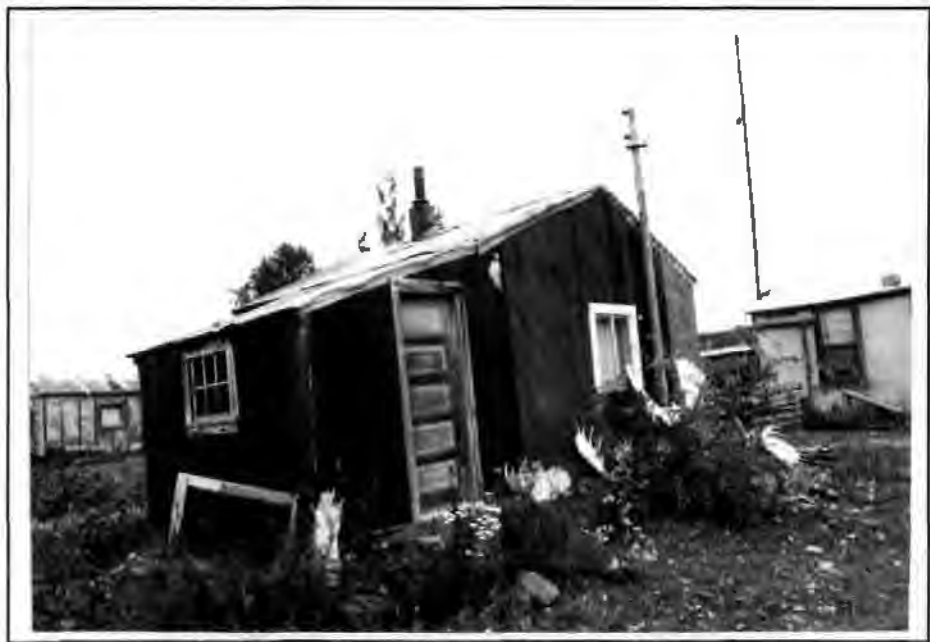
**Figure 137. Bunkhouse #1, 1993.**  
The view is looking southeast.

**Bunkhouse #1 (IDT-205)** is a square, one-story, wood frame building with an addition (Figure 137). The foundation is logs on grade. The gable roof consists of corrugated metal. The bunkhouse measures 15'2" on each side. The exterior is covered with roofing felt over horizontal wood siding. The main entry is on the west elevation, which has a two-light, fixed sash window. A shed roof addition measuring 7'7"x9'6" is located on the north elevation. The roof is covered with corrugated metal. The addition has a six-light, fixed sash window facing north and a five-panel door facing west. A six-light, fixed sash window is located on the south elevation of the bunkhouse. The interior walls are covered by wood siding. The ceiling is celotex and the flooring is tongue and groove.

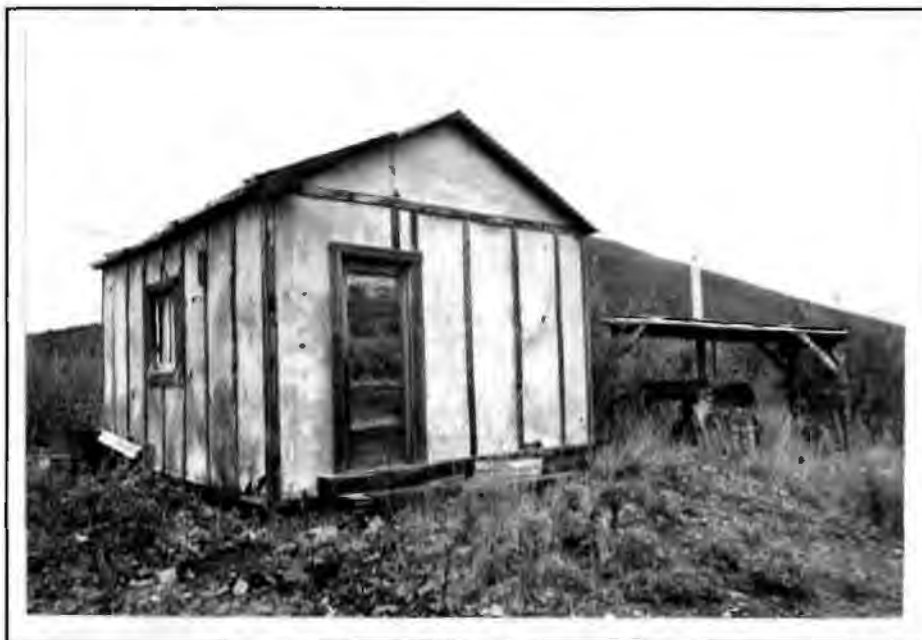
**Figure 139. Bunkhouse #2, 1993.**  
The view is looking northeast.

(IDT-207) is a rectangular, one-story, wood frame building (Figure 139) located 38' east of the Bathhouse (IDT-206). The foundation is beams and barrels on grade. The gable roof is made of corrugated metal. The Bunkhouse measures 12'2"x16'4". Celotex and batten boards cover the exterior walls. The main entry is on the south elevation, which contains a five-panel door. The north and west elevations have a two-light, fixed sash window. A three-panel door is located on the east elevation.

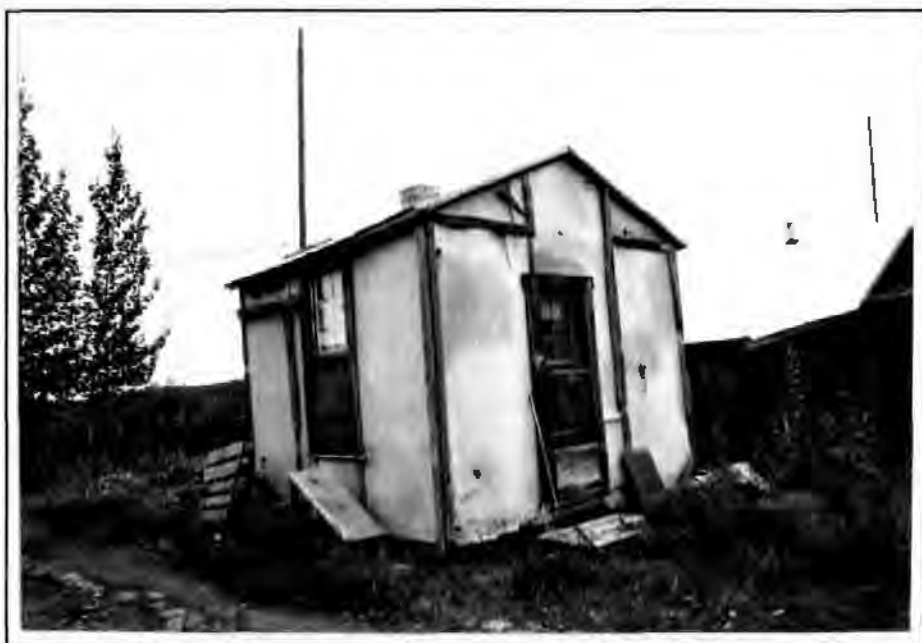
**Figure 140. Bunkhouse #3, 1993.**  
The view is looking southeast.

**Bunkhouse #3 (IDT-208)** is a square, one-story, wood frame building (Figure 140) located 26'6" south of Bunkhouse #1. The foundation is logs on grade. The gable roof is made of corrugated metal. The building is 12' on each side. Celotex with batten boards covers the exterior walls. The main entry is on the west elevation, which contains a three-panel door with six lights. A six-light, fixed sash window is located on the north elevation.

Peter Miscovich built Bunkhouse #3 at the Discovery/Peter Miscovich Camp in the 1930s or 1940s. He built the structure for his brother when his brother came to Alaska from South America. John Miscovich moved the building to the Riley/Otter Creek Camp in the late 1950s or early 1960s (Miscovich 1995:VI-104).

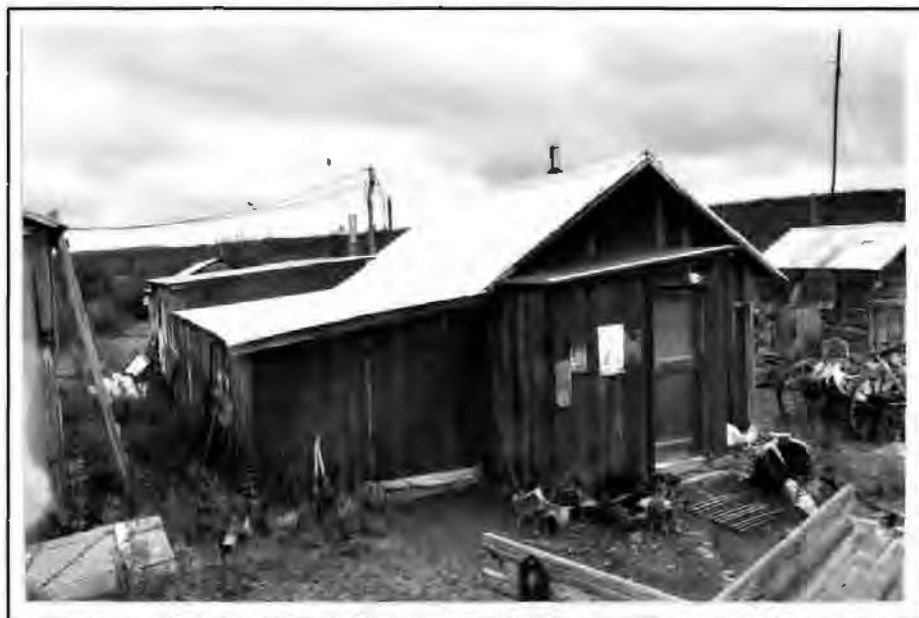
**Figure 141. The Office and Workshop Building, 1993. The view is looking southeast.**

**The Office and Workshop (IDT-209)** is a rectangular, one-story, wood framed building with four additions (Figure 141). The office measures 14'x16'4". The foundation is logs and beams on grade. The gable roof is made of corrugated metal. The siding consists of roof-

ing felt and battens. The main entry is on the west elevation, which has a one-light, fixed sash window on the south end. The north end of the west elevation is covered by a shed roofed arctic entry measuring 4'x8'. The roof of the arctic entry is covered with roofing felt. A one-panel door with one-light faces west. The east elevation of the Office has a 2/2 horizontal double-hung window.

A rectangular, wood frame shed is located on the north side of the Office. The foundation is on beams and the shed roof is covered with corrugated metal. The addition measures 9'5"x16' and the exterior siding consists of roofing felt over horizontal wood siding. A plank door covered with roofing felt opens to the west. A pair of two-light, fixed sash windows are located on the north elevation.

Another rectangular, wood frame shed addition is attached to the east side of this shed. The foundation consists of beams on grade and the shed roof is covered with corrugated metal. The addition measures 9'5"x22' and the exterior is covered with roofing felt over horizontal wood siding. The south elevation has two, two-light, fixed sash windows. The north elevation has a three-panel door with one-light, a six-light, fixed sash window, and a two-light, fixed sash window. This building is used as a laboratory.

A third rectangular, shed roof addition is connected to the west side of the second addition. The foundation is beams on grade. The gable roof is made of corrugated metal. The addition measures 9'5"x13'6" and the exterior is covered with plastic tarp over horizontal wood siding. A vertical plank door is located on the east elevation. A six-light, fixed sash window is located in the north elevation. This shed once housed a pump powered by a diesel engine.

A fourth addition is attached to the south side of the third addition. The foundation is not visible. The shed roof is covered with corrugated metal. The addition measures 17'2"x19'10" and the exterior is covered with plywood. The south elevation has a triple six-light window, a large plywood door, and a band of four single-light, fixed sash windows covered with plastic. The east elevation has a three-panel door with four lights and a triple two-light, fixed sash window. The west elevation has a three-panel door. This addition is a garage in the winter and is used to process concentrates in the summer.

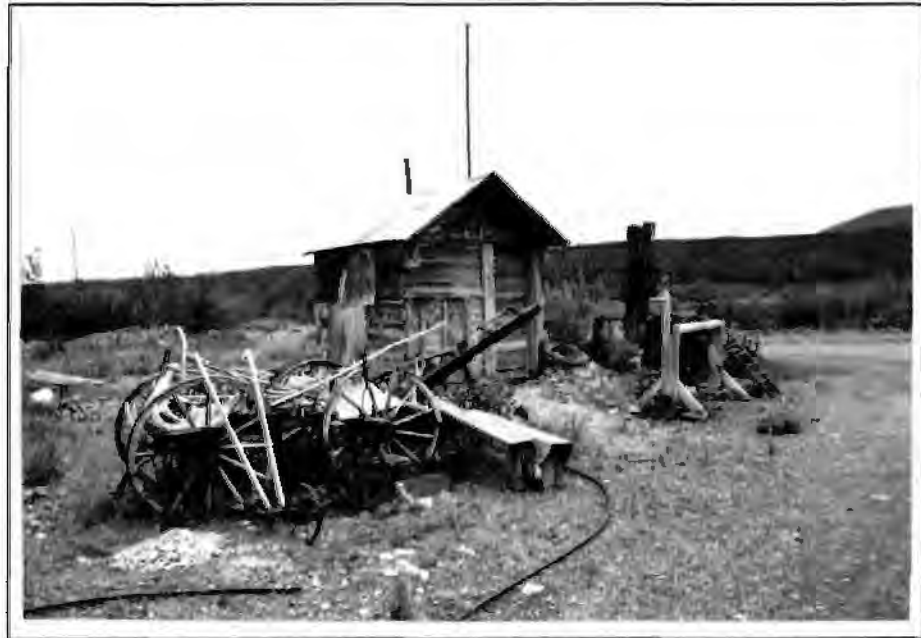
Figure 142. The Well House, 1993.  
The view is looking southeast.

The Well House (IDT-210) is a square, one-story, wood frame building (Figure 142). The foundation is logs on grade. The gable roof is covered with corrugated metal. The building measures 8'x10'2". The exterior is covered with a combination of shiplap and horizontal wood siding. A five-panel door is located on the west elevation. The building is surrounded by old mining equipment that John Miscovich has collected, including pumps, wagons, coils of rubber hose, and stamps for crushing lode ore.

This building was constructed on Slate Creek in the 1930s. It was used as a meat drying shed and had meat hooks hanging from the ceiling. John Miscovich moved the building to the Riley/Otter Creek Camp in the 1960s and the building shelters his well (Miscovich, personal communication, August 9, 1993).

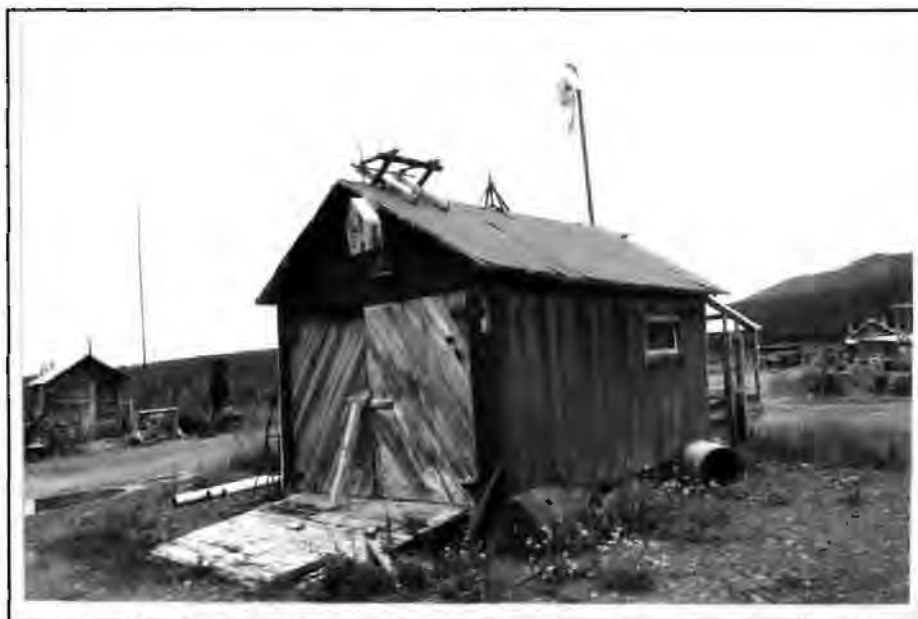
Figure 143. The DeHouse Residence/Miscovich Garage. 1993. The view is looking southeast.

The DeHouse Residence/Miscovich Garage (IDT-211) is a rectangular, one-story, wood frame building (Figure 143). The foundation is wood blocks on grade. The gable roof is covered with corrugated metal. The garage measures 12'6"x24'6". Roofing felt over horizontal wood siding covers the exterior walls. The main entry is on the north elevation, which contains a pair of large diagonal plank doors. A ramp leads from the doors to the ground. The east elevation has a boarded up door. A single-light, fixed sash window is located in the west elevation. A shed roof greenhouse addition is centered on the south elevation. The roof of the addition is covered with fiberglass. The addition measures 8'4"x12'6".

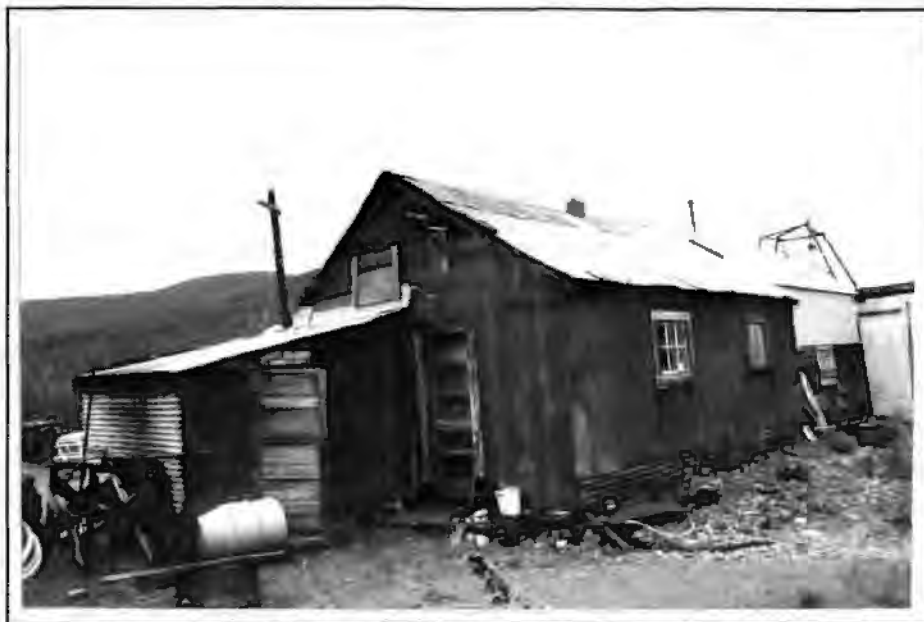
**Figure 144. The Machine Shop (center) and additions, 1993. The view is looking northeast.**

The Machine Shop (IDT-213) is a rectangular, 1.5 story, wood frame building with three additions (Figure 144). The foundation is horizontal timbers on grade. The gable roof is corrugated metal over shiplap. The shop measures 16'5"x23'11" and the exterior is covered with roofing felt over shiplap. The south elevation has two six-light, fixed sash windows and the north elevation has a two-light, fixed sash window. A small boarded up window is located under each gable. The west elevation has a five-panel door and a shed addition measuring 8'2"x10'. The addition, which houses a generator, has a shed roof covered with corrugated metal over wood decking. A five-panel door faces south.

A rectangular, one-story wood frame addition, which serves as a tractor garage, is attached to the east side of the Machine Shop. The foundation is vertical steel poles on grade. The gable roof is covered with aluminum. The addition measures 12'5"x19'6". The exterior is covered with a combination of shiplap and wood siding, except for the south elevation which is covered with aluminum. A pair of side-opening plywood doors is located on the east elevation. A five-panel door on the west elevation opens into the Machine Shop. The south elevation has a six-light, fixed sash window. A five-panel door on the south elevation opens into the north addition.

The rectangular, one-story, wood frame addition has a foundation of horizontal timbers on grade. The shed roof is covered with aluminum over wood decking. The addition measures 20'x30'4" and the exterior is covered with wood siding. A pair of single-light, fixed sash windows and a single-panel door with one-light are located on the east elevation. The north

elevation has a pair of single-light windows and a pair of fixed sash windows, one with six lights and the other with a single light. A pair of large side-opening doors and a six-light, fixed sash window are located on the west elevation. One of the swinging doors also has a six-light, fixed sash window.

The Machine Shop was originally a bunkhouse. It was constructed on Slate Creek in the 1940s, after World War II. John Ogriz moved the building to another location in the valley. John Miscovich moved it to its present location in the early 1960s. Miscovich converted the bunkhouse into a machine shop after a fire in 1964 destroyed his old machine shop. He built the additions after 1964 (Miscovich 1995:VI-105).

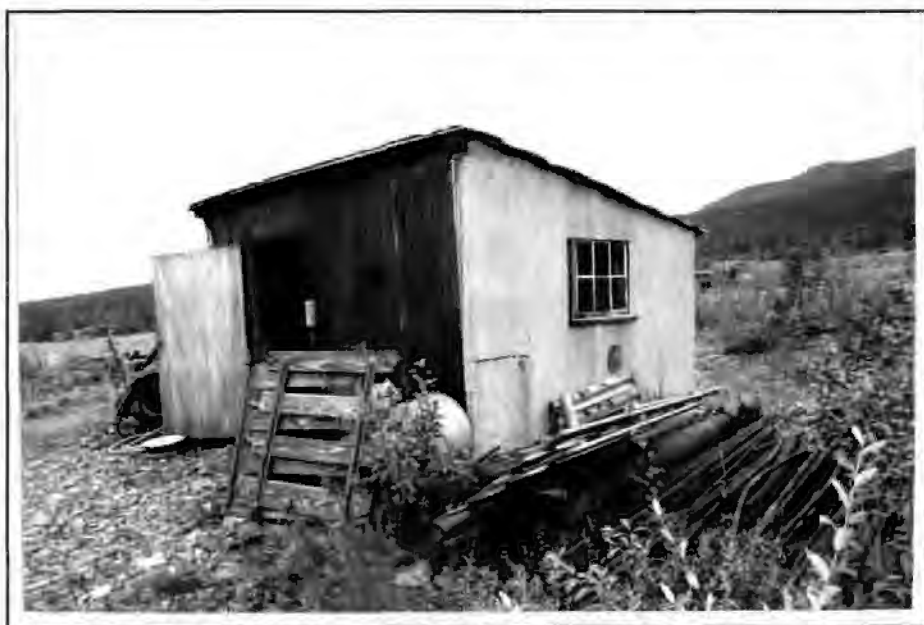
**Figure 145. The Fuel Storage Shed, 1993. The view is looking southeast.**

The Fuel Storage Shed (IDT-214) is a square, one-story, wood frame building (Figure 145) located 25' southwest of the Machine Shop. The foundation is on grade. The shed roof and exterior are covered with corrugated metal. The shed measures 11'2"x13'2". The main entry is on the north elevation, which has a plank door. A six-light, fixed sash window is located on the west elevation.

The date the Fuel Storage Shed was built is unknown. It belonged to Fred Patterson, who resided near the Discovery/Peter Miscovich Camp. Patterson moved his house to Flat and left the shed. John Miscovich moved the shed, which consisted of framing and a roof, to the Riley/Otter Creek Camp and put siding on it. He used the building as a generator shed before converting it to fuel storage (Miscovich 1995:VI-105).

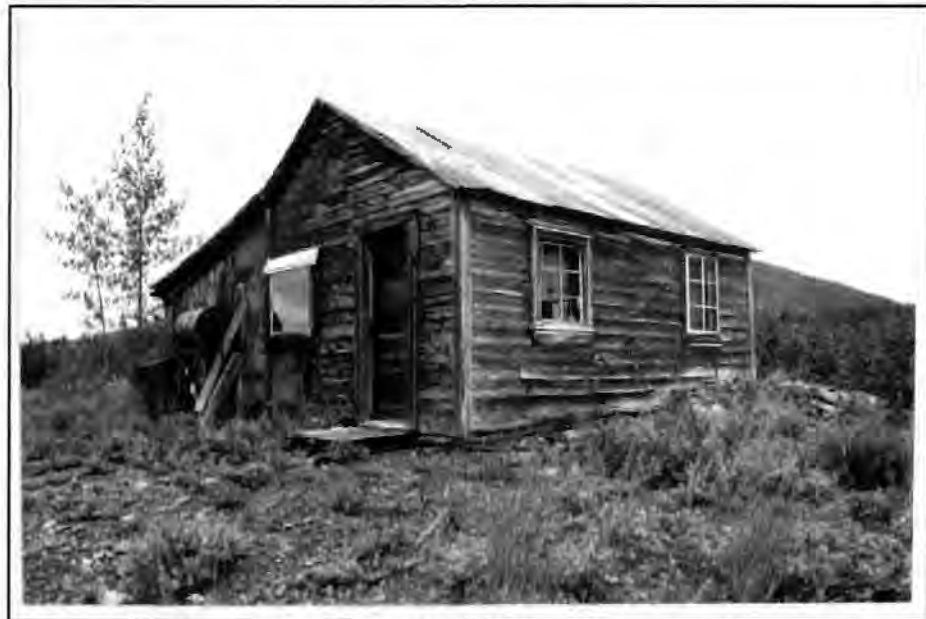
**Figure 146. The Riley Office/Kobler Cabin, 1993. The view is looking northwest.**

The **Riley Office/Kobler Cabin (IDT-215)** is a rectangular, one-story, wood frame building (Figure 146). The foundation is horizontal timbers. The gable roof is covered with corrugated metal over wood decking. The building measures 18'3"x24'9" and shiplap siding covers the exterior walls. The main entry is on the south elevation, which has a five-panel door and a single-light, fixed sash window. The east elevation has a six-light, fixed sash window and a single-light, fixed sash window covered by a six-light storm window. The north elevation has a two-light, fixed sash window and a six-light, fixed sash window. A rectangular, one-story addition on the west elevation has a shed roof covered with corrugated metal and measures 13'1"x14'4". The north and south walls are covered with shiplap and the west wall is covered with horizontal wood siding. A four-light, fixed sash window is located on the west side of the addition.

A wood frame outhouse with a shed roof is located 56' north of the cabin. The outhouse measures 4'x5'. The roof and sides are covered with roofing felt over wood decking. A plank door faces west.

The Riley Office/Kobler Cabin is the oldest building in the Riley/Otter Creek Camp and one of the oldest in the Flat area. It was built about 1910 when J.E. Riley was mining in the area using a Bagley Scraper. After Riley started

dredging, the building became the J.E. Riley Investment Company office. Arnold Kobler lived in the building when he became part owner of the Otter Creek Dredging Company in the mid-1950s. John Miscovich moved the building, including the addition, to its present location in the 1960s. The shed addition is a storage room (Miscovich 1995:VI-101-102, 105, 107).

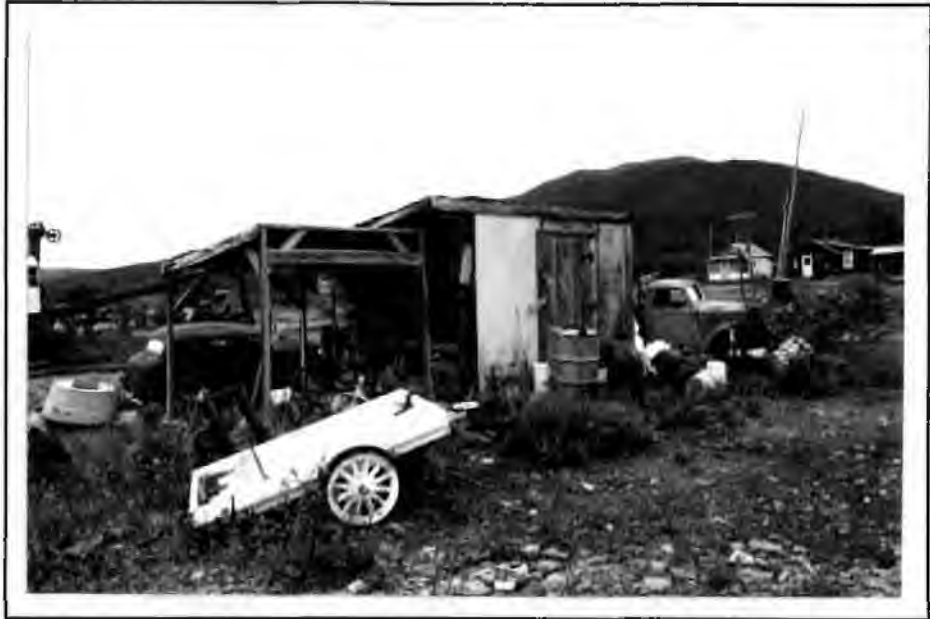
Figure 147. The Warehouse, 1993.  
The view is looking northwest.

The Warehouse (IDT-216) is a rectangular, one-story, log framed building (Figure 147). The foundation consists of beams and logs on grade. The building measures 10'5"x11' and the shed roof is covered with corrugated metal. The exterior siding is celotex and batten boards. The main entry is on the east elevation, which has a plank door. A six-light, fixed sash window is located on the north elevation.

The original location and the date the warehouse was built are unknown. Ernie Norman used it as a pig pen in the 1970s, when it was west of the present location of the Flat Post Office (IDT-124). John Miscovich moved the building to the Riley/Otter Creek Camp in about 1979 and has been using the building as a warehouse (Miscovich 1995:VI-106).
